Water Compliance Inspection Report

**NPDES
Inspection Report**

**Clearbrook Holsteins
Sumas, Washington**

March 30, 2010

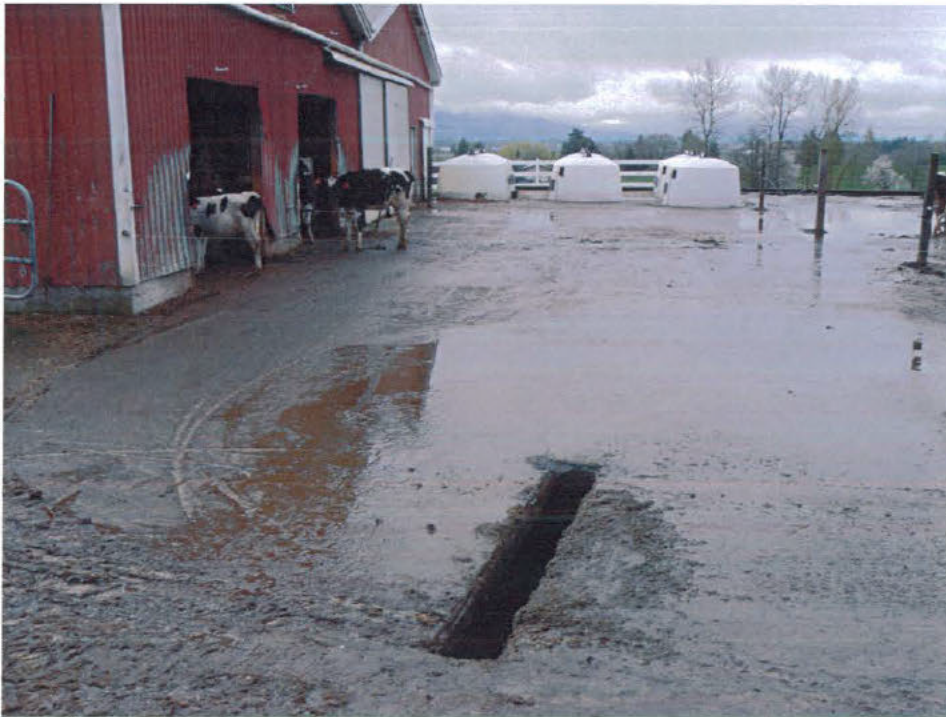
Photo #2: View in the vicinity of one of the below ground manure pits at the main facility of the dairy. Wastes entering this pit are pumped to another below ground pit before it is routed to a solids separator.

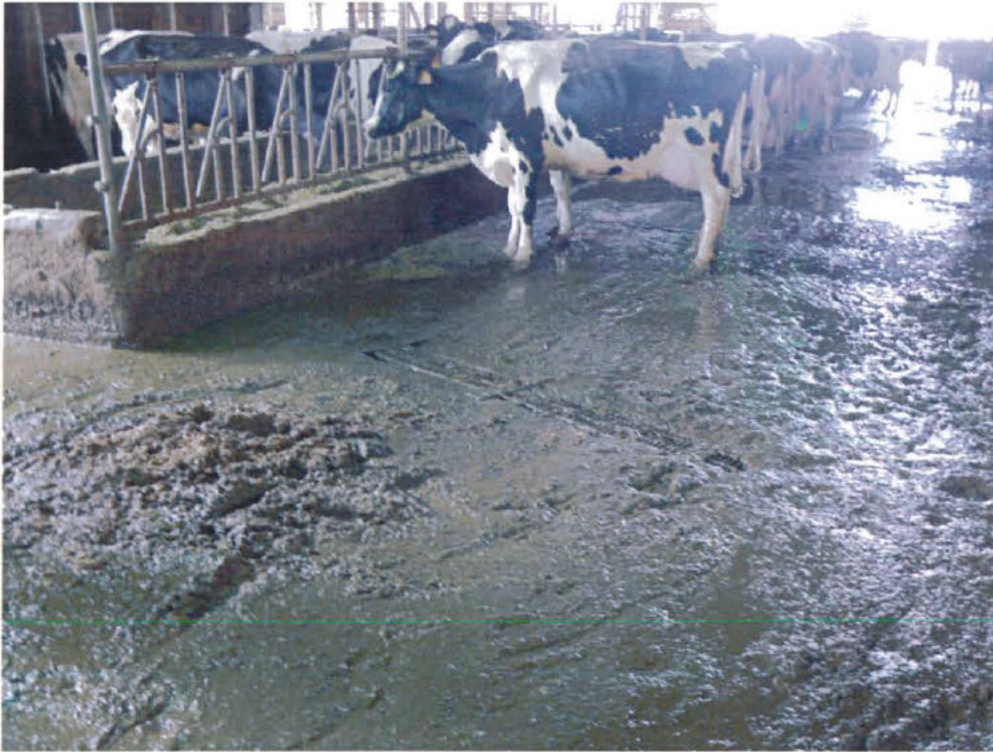
Photo #3: View in the vicinity of the second below ground manure pit at the main facility of the dairy. The contents of this pit are pumped to the solids separator.

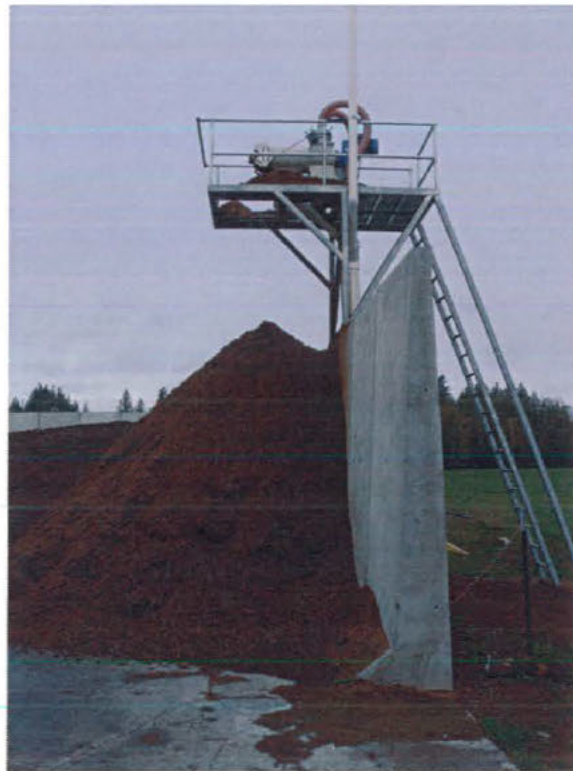
Photo #4: View of the solids separator at the main facility.

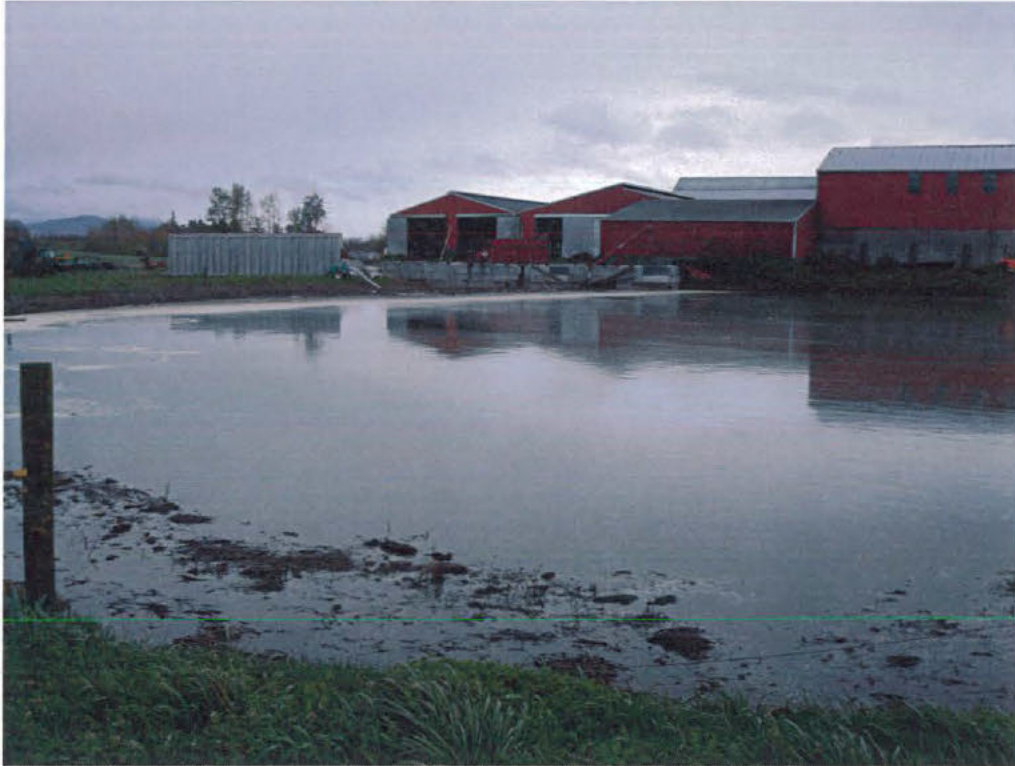
Photo #5: Easterly view showing the waste storage lagoon at the main facility.

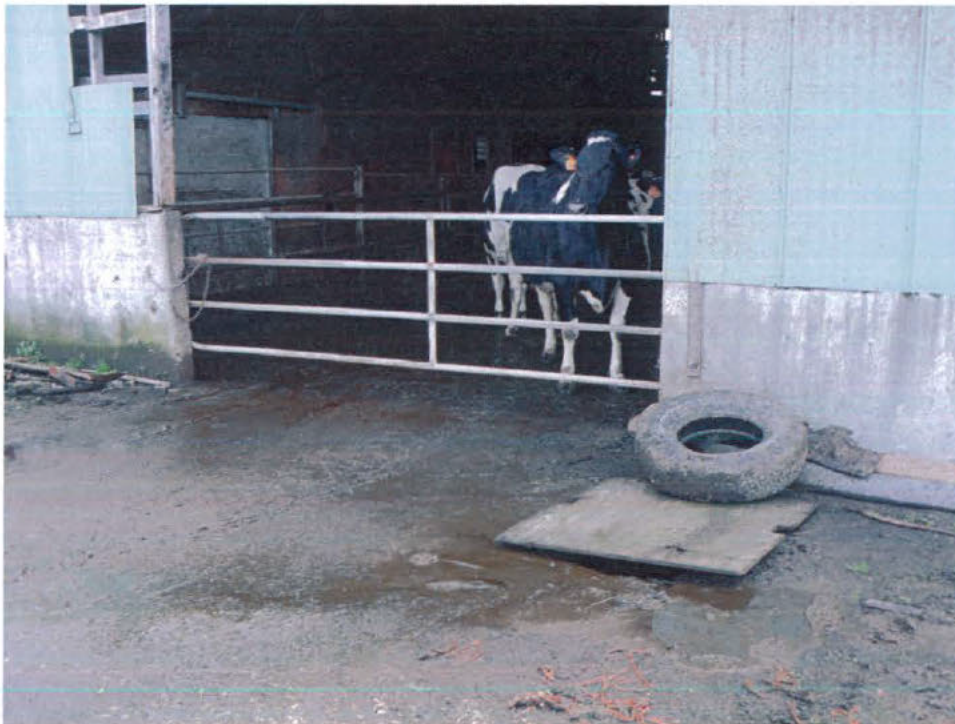
Photo #6: View of the entrance to the barn on the leased property. The below ground manure pit is located in the foreground of this photograph.

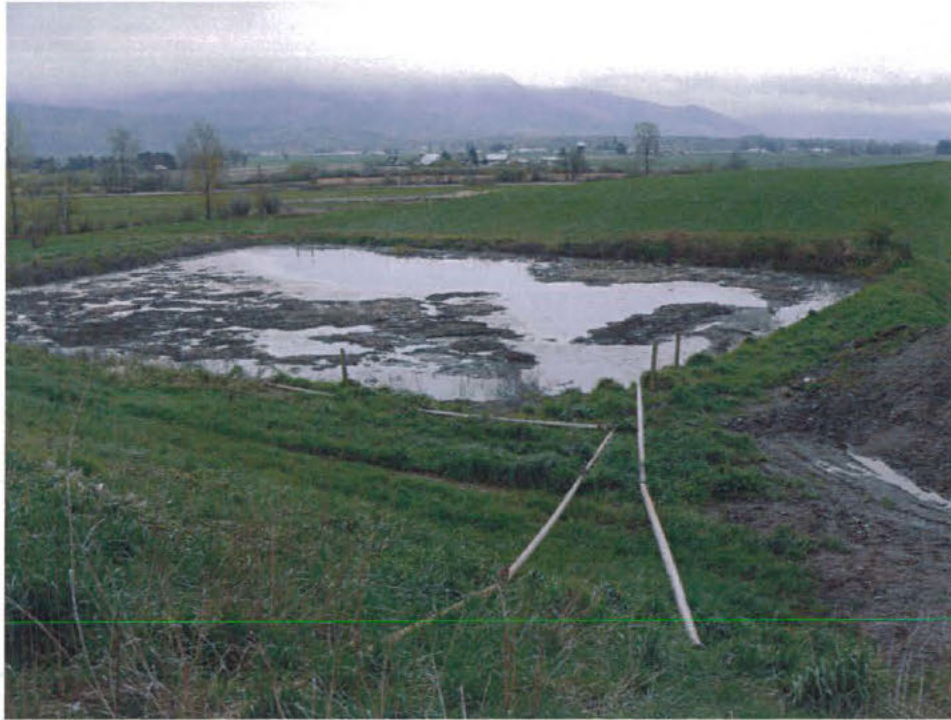
Photo #7: Southeasterly view of the waste storage lagoon on the leased property.

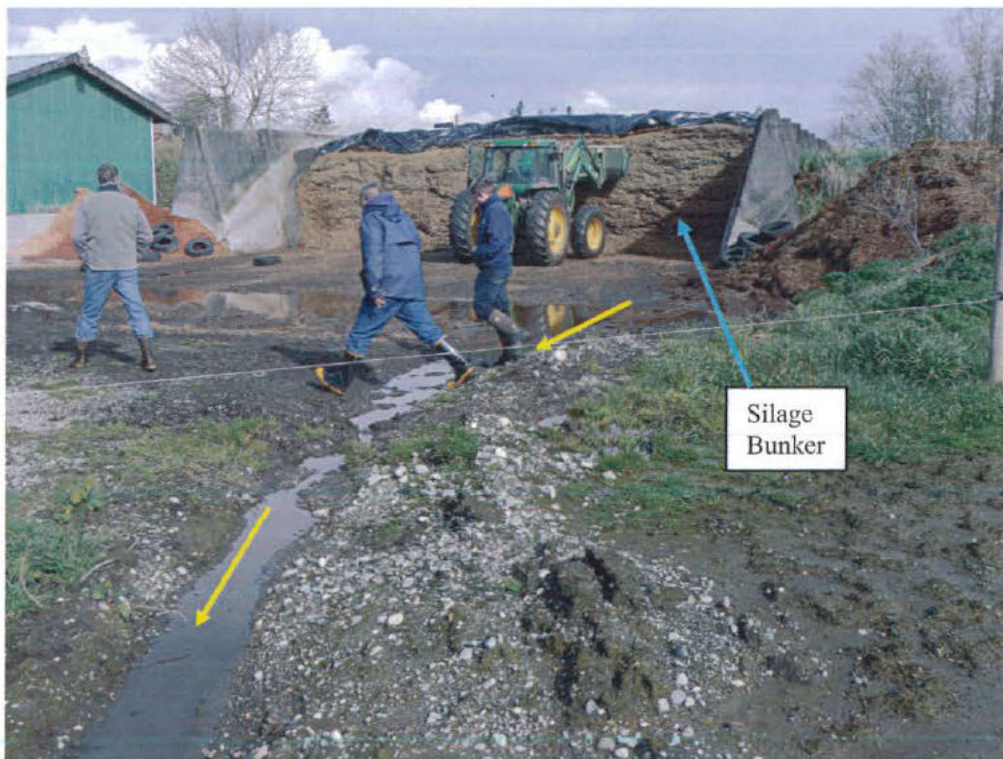
- B. Silage Drainage from the Leased Property While inspecting the silage bunker on the leased property I saw drainage emanating from the south side of the silage bunker. This drainage flowed in a southeasterly direction down a hill and through a grassy area toward a drainage ditch located just east of the lagoon (on this leased property). See photograph #s 8 to 12 of attachment B and attachment D for details of this silage drainage.

Note that the drainage from the silage bunker appeared to be channeled and directed away from the silage bunker. I told Mr. Visser that this silage drainage was an area of concern. He responded by saying that this drainage is typically handled by a tile drain which routes silage drainage into the waste storage lagoon, however, this drain was not allowing the silage drainage to drain quickly enough. He also said that he is working with the land owner to repair the tile drain.

Although I did not see this drainage enter the nearby ditch at the time of the inspection, the concern is that this drainage could enter this ditch during a rainfall event and ultimately flow into Johnson Creek.

Photo #8: Northerly view showing the silage bunker on the leased property. Note the runoff in the vicinity of the bunker. Also note the channel routing runoff from the area of the bunker.

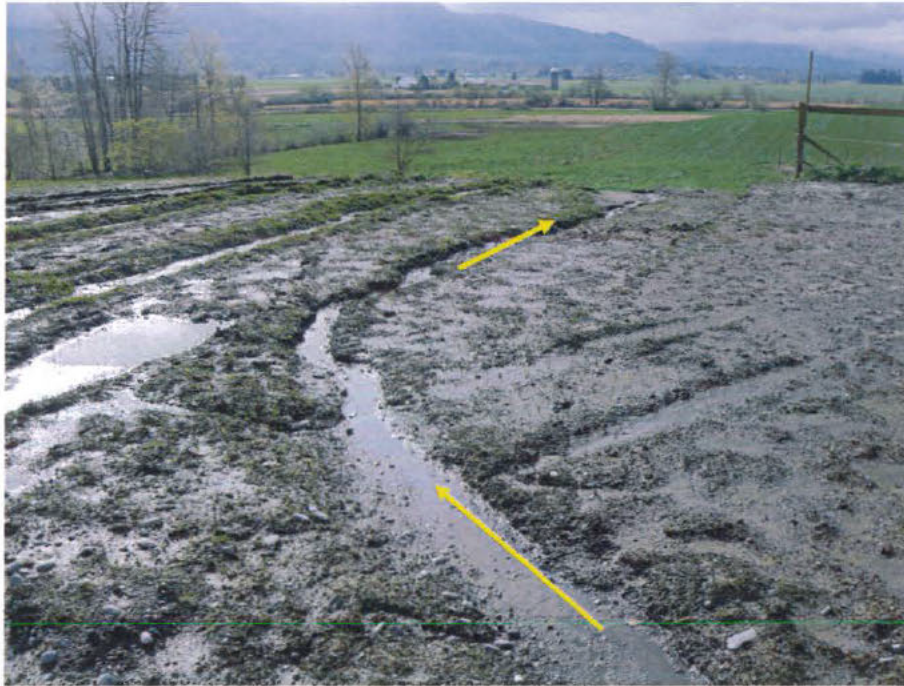
Photo #9: Southerly view showing the runoff channel routing runoff from the vicinity of the silage bunker (located on the leased property). The silage bunker is located behind the photographer. This runoff channel continues down a hill on to nearby pastures. See the next photograph for further details of this runoff pathway.

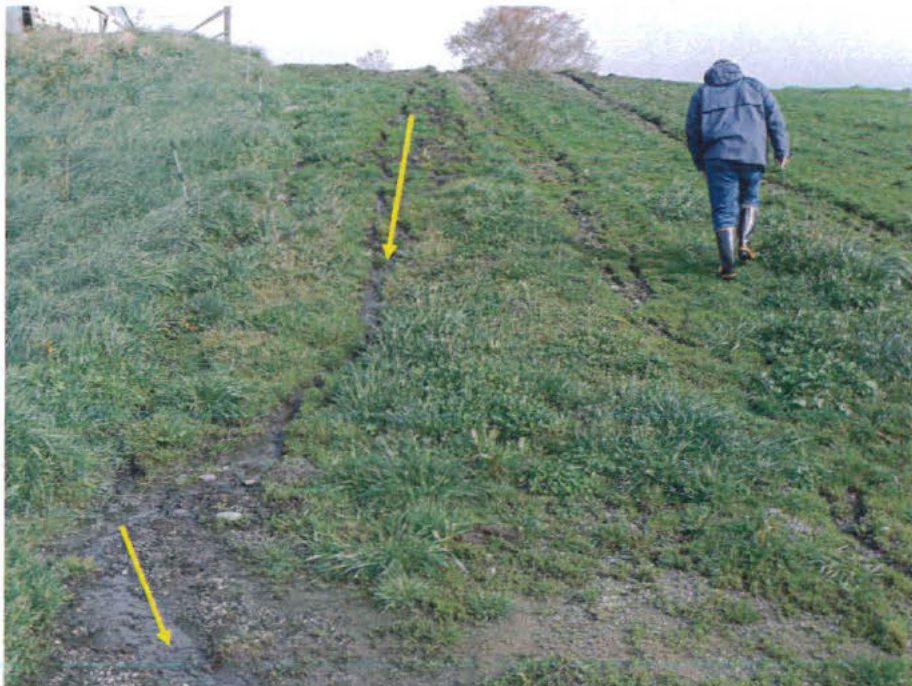
Photo #10: Northerly view showing the runoff channel routing liquid from the vicinity of the silage bunker (on the leased property). The silage bunker is located just over this hill. See the previous two photographs for additional details.

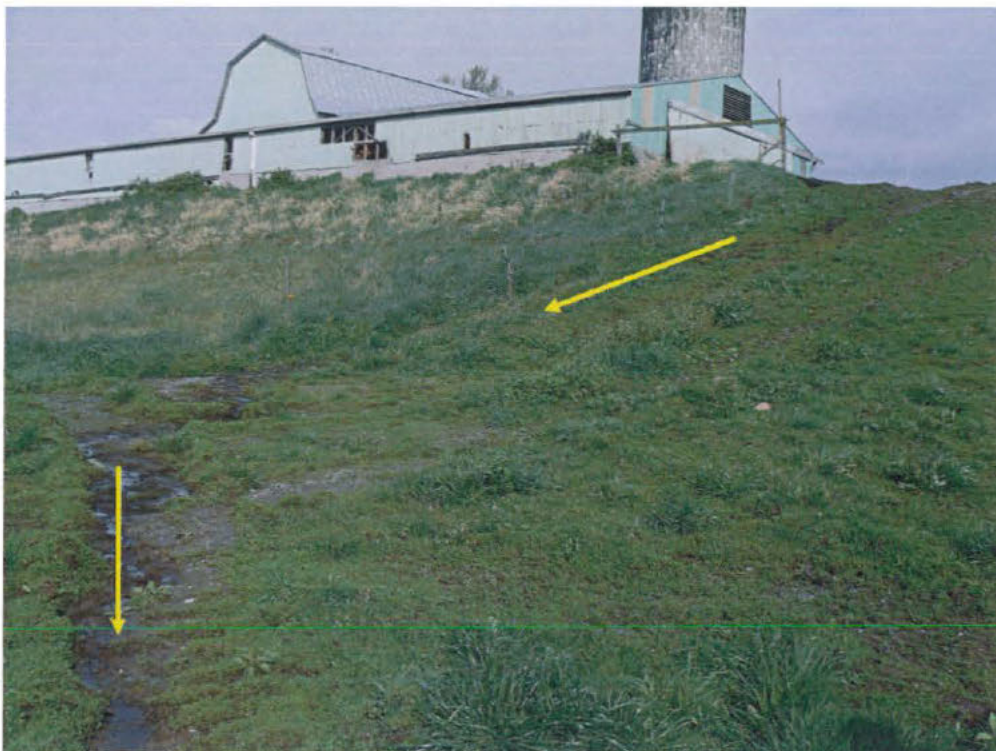
Photo #11: Northwesterly view showing the barn (on the leased property) in the background and the runoff channel in the foreground. This channel starts from the area of the silage bunker located to the right of the barn area.

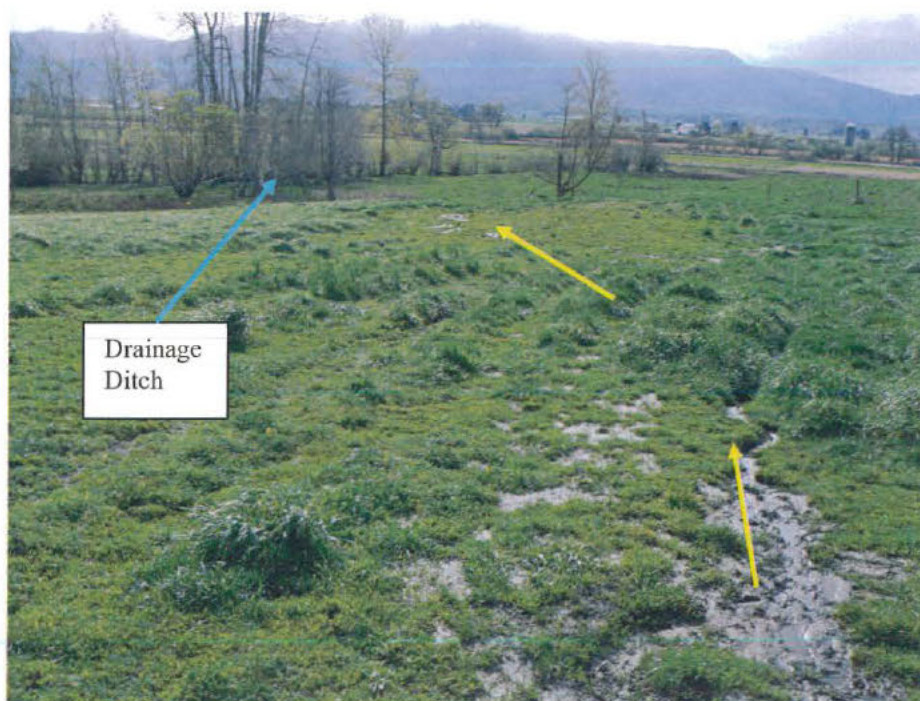
Photo #12: Southeasterly view of the silage runoff channel (on the leased property) leading toward the direction of a ditch which ultimately connects with Johnson Creek.
